Debris/Ice/TPS Assessment and Integrated Photographic Analysis of Shuttle Mission STS-65

*Gregory N. Katnik, Barry C. Bowen, J. Bradley Davis,
Vehicle Engineering/Mechanical System Division/ET Section,
Kennedy Space Center, Florida*

July 8, 1994

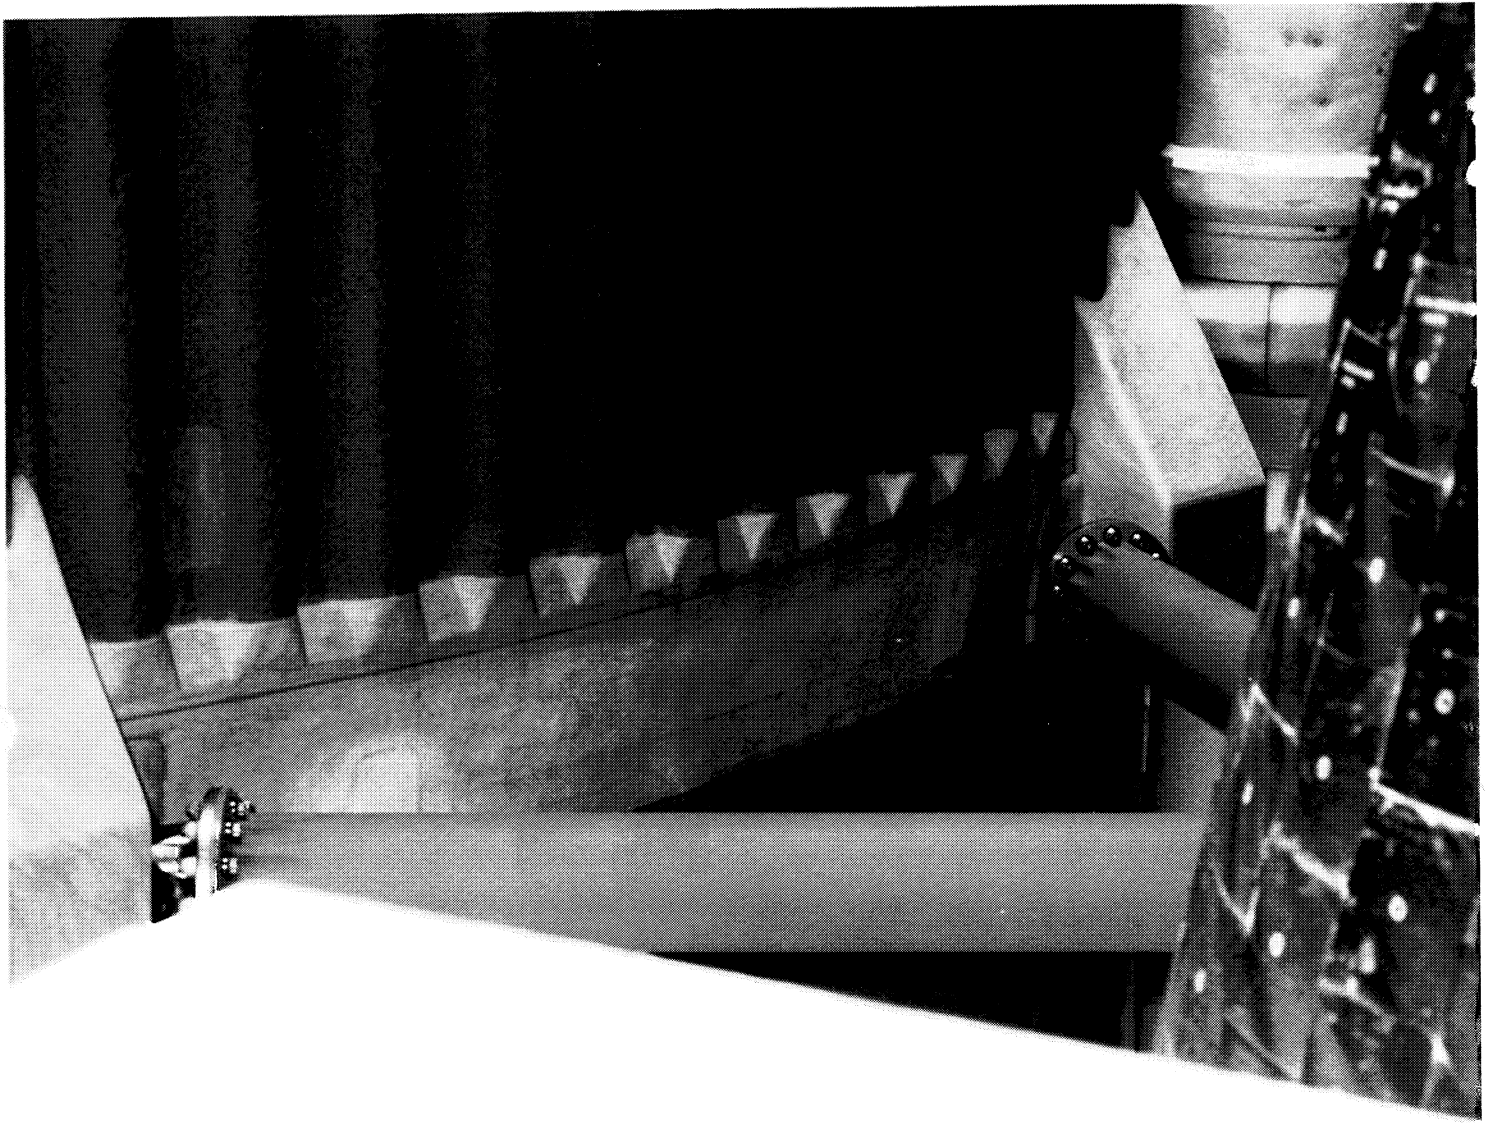
Photo 2: Bipod Jack Pad Closeouts

View of ET bipod jack pad closeouts prior to cryoload

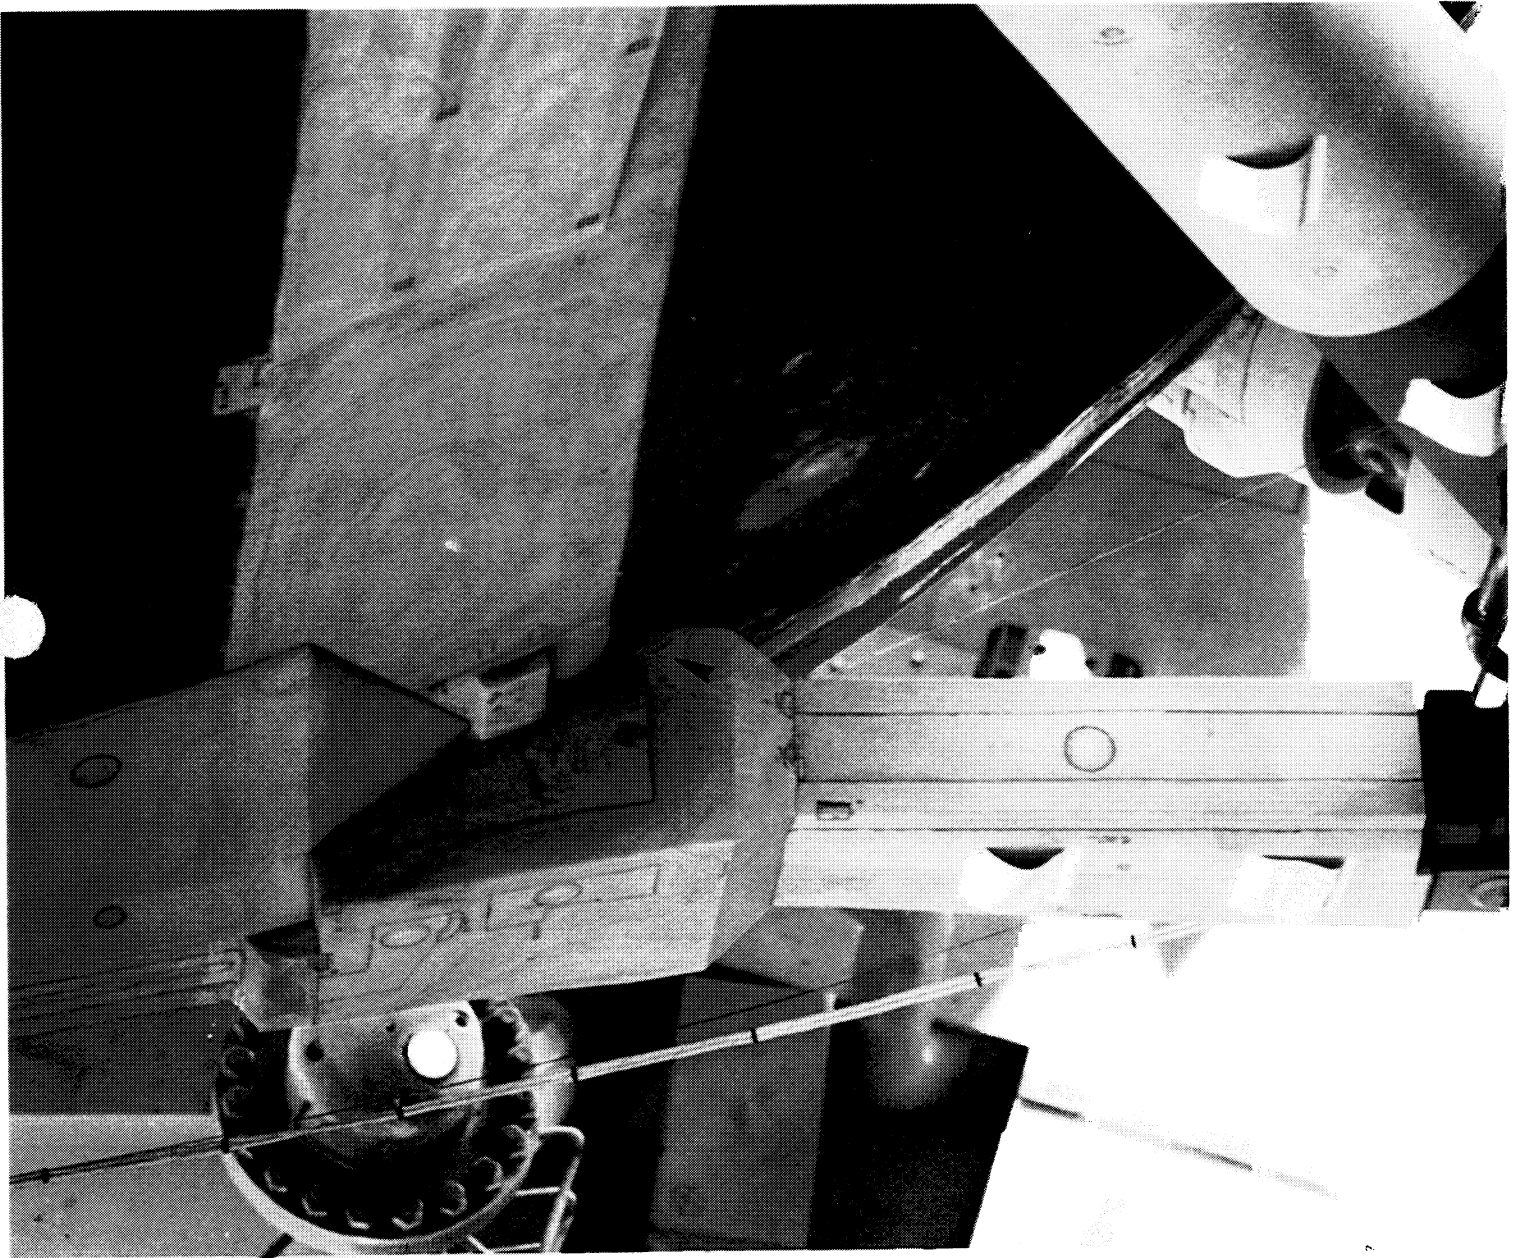
A smaller than usual crack, 2 inches long by 1/4 inch wide, was present in the -Y ET/SRB cable tray forward surface TPS. The presence of the crack was acceptable for flight per the NSTS-08303 criteria.

Anomaly 002 documented a 2 inch by 1/4 inch crack in the forward surface TPS of the -Y vertical strut.

Photo 5 : Stress relief crack in -Y vertical strut cable tray TPS

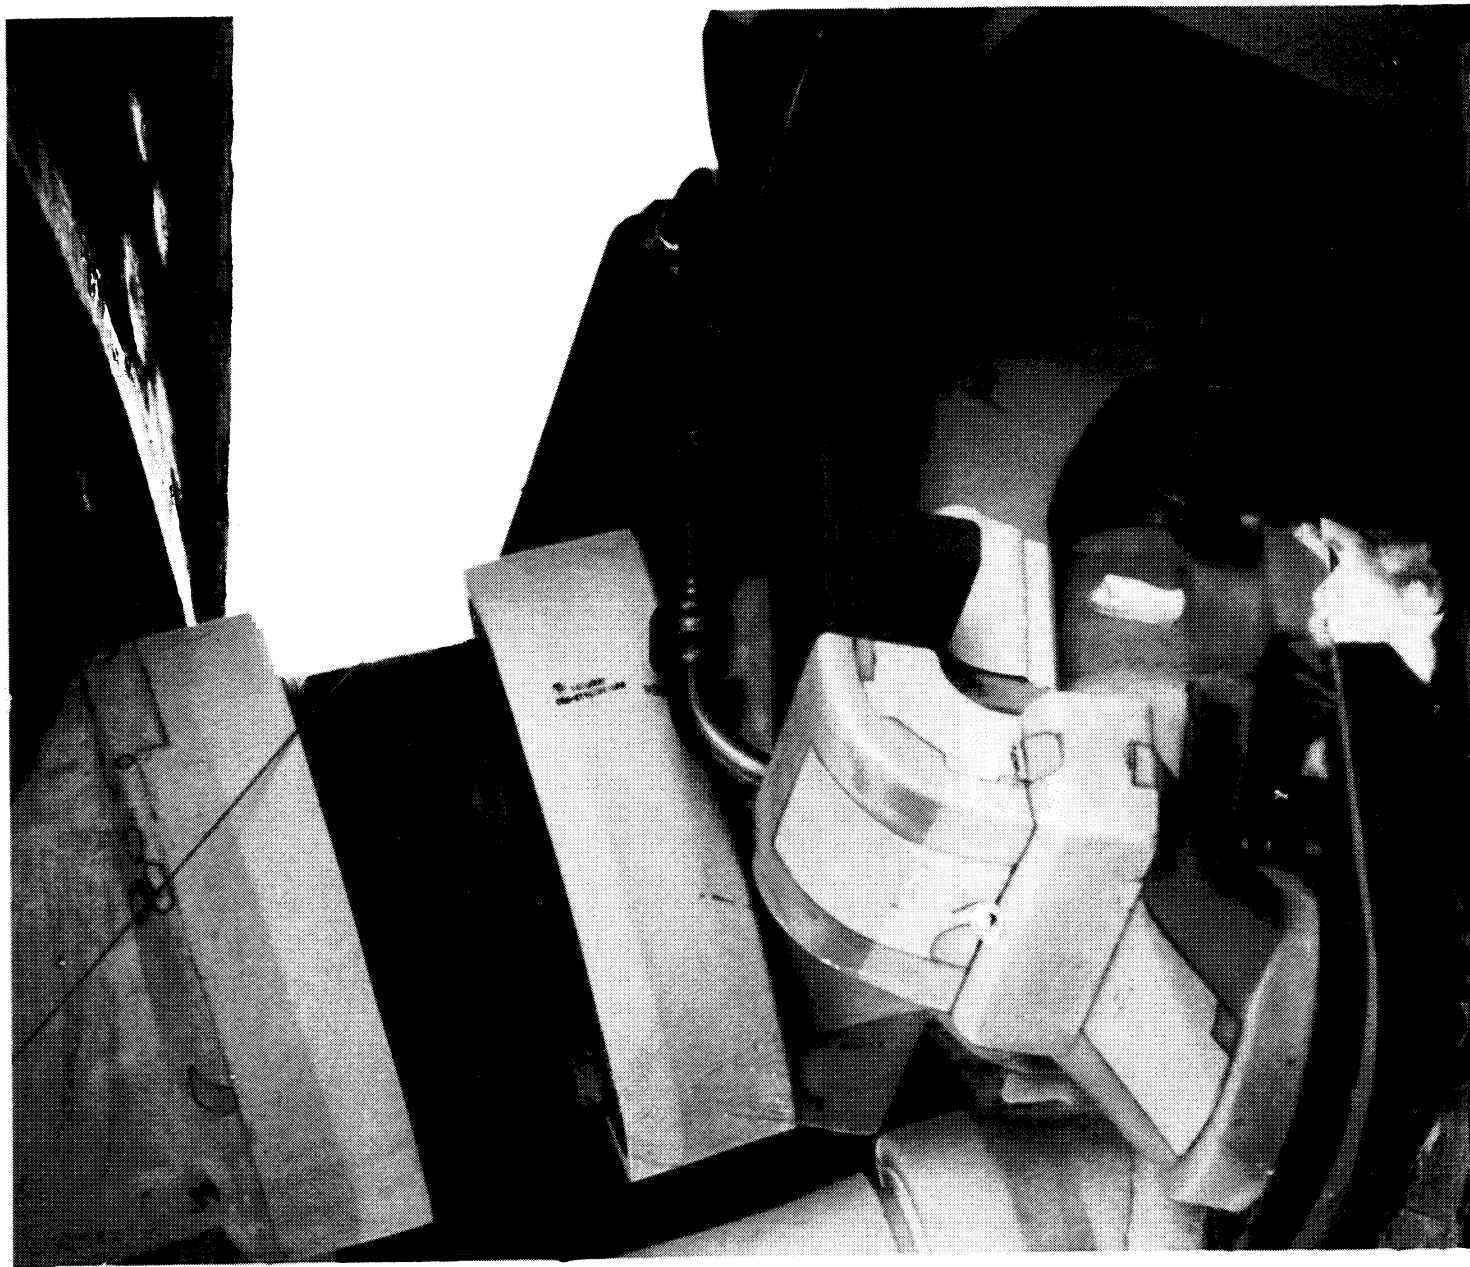
Photo 6 : LH2 ET/Orbiter umbilical

Less than usual ice/frost had formed on the umbilical during cryoload

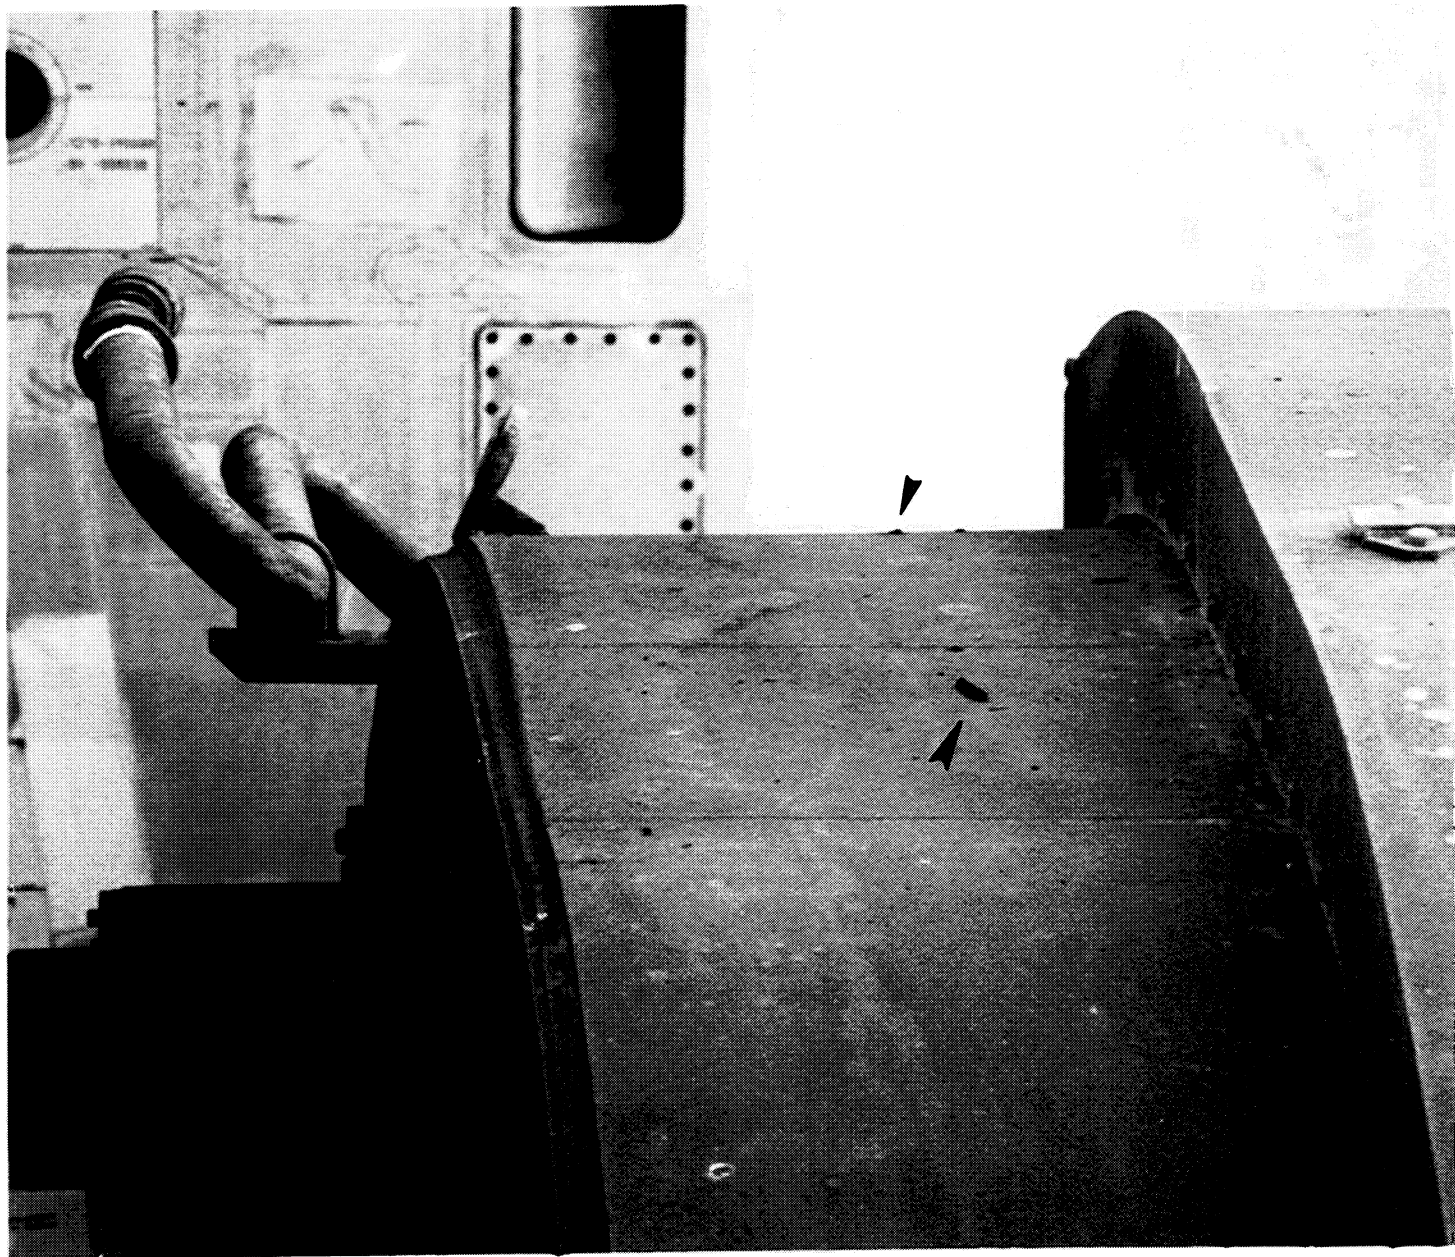
Photo 7 : Debris on top of LH2 TSM

Pen cap and washer/retainer from Orbiter 50-1 door closout were removed

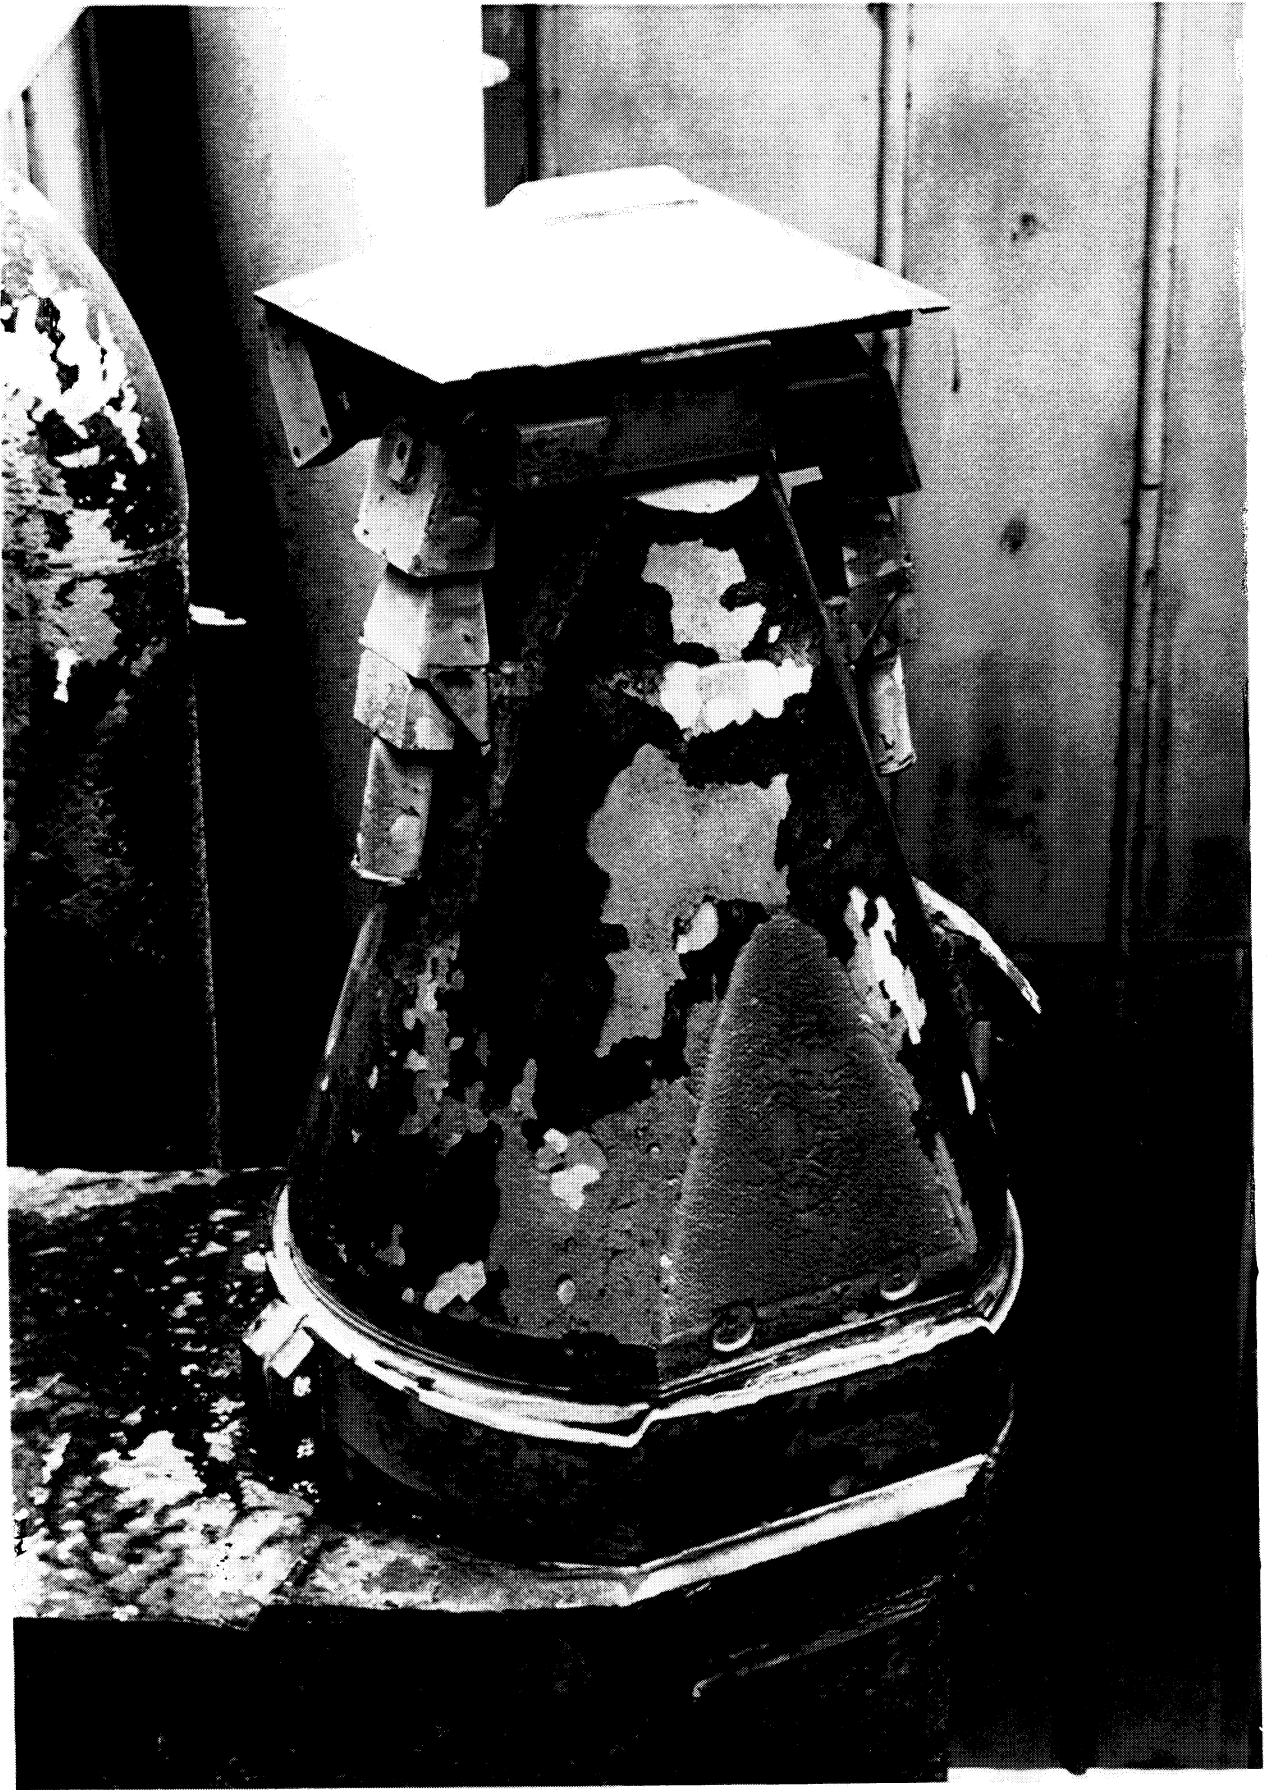
South SRB HDP erosion was typical. All south HDP shoe EPON shim material was intact. There was no visual indication of a stud hangup on any of the south holddown posts. All of the north HDP doghouse blast covers were in the closed position. Erosion of the blast covers was normal and there were no burn-throughs. The SRB aft skirt purge lines and T-0 umbilicals exhibited typical exhaust plume damage.

Photo 8 : Post launch condition of north holddown post

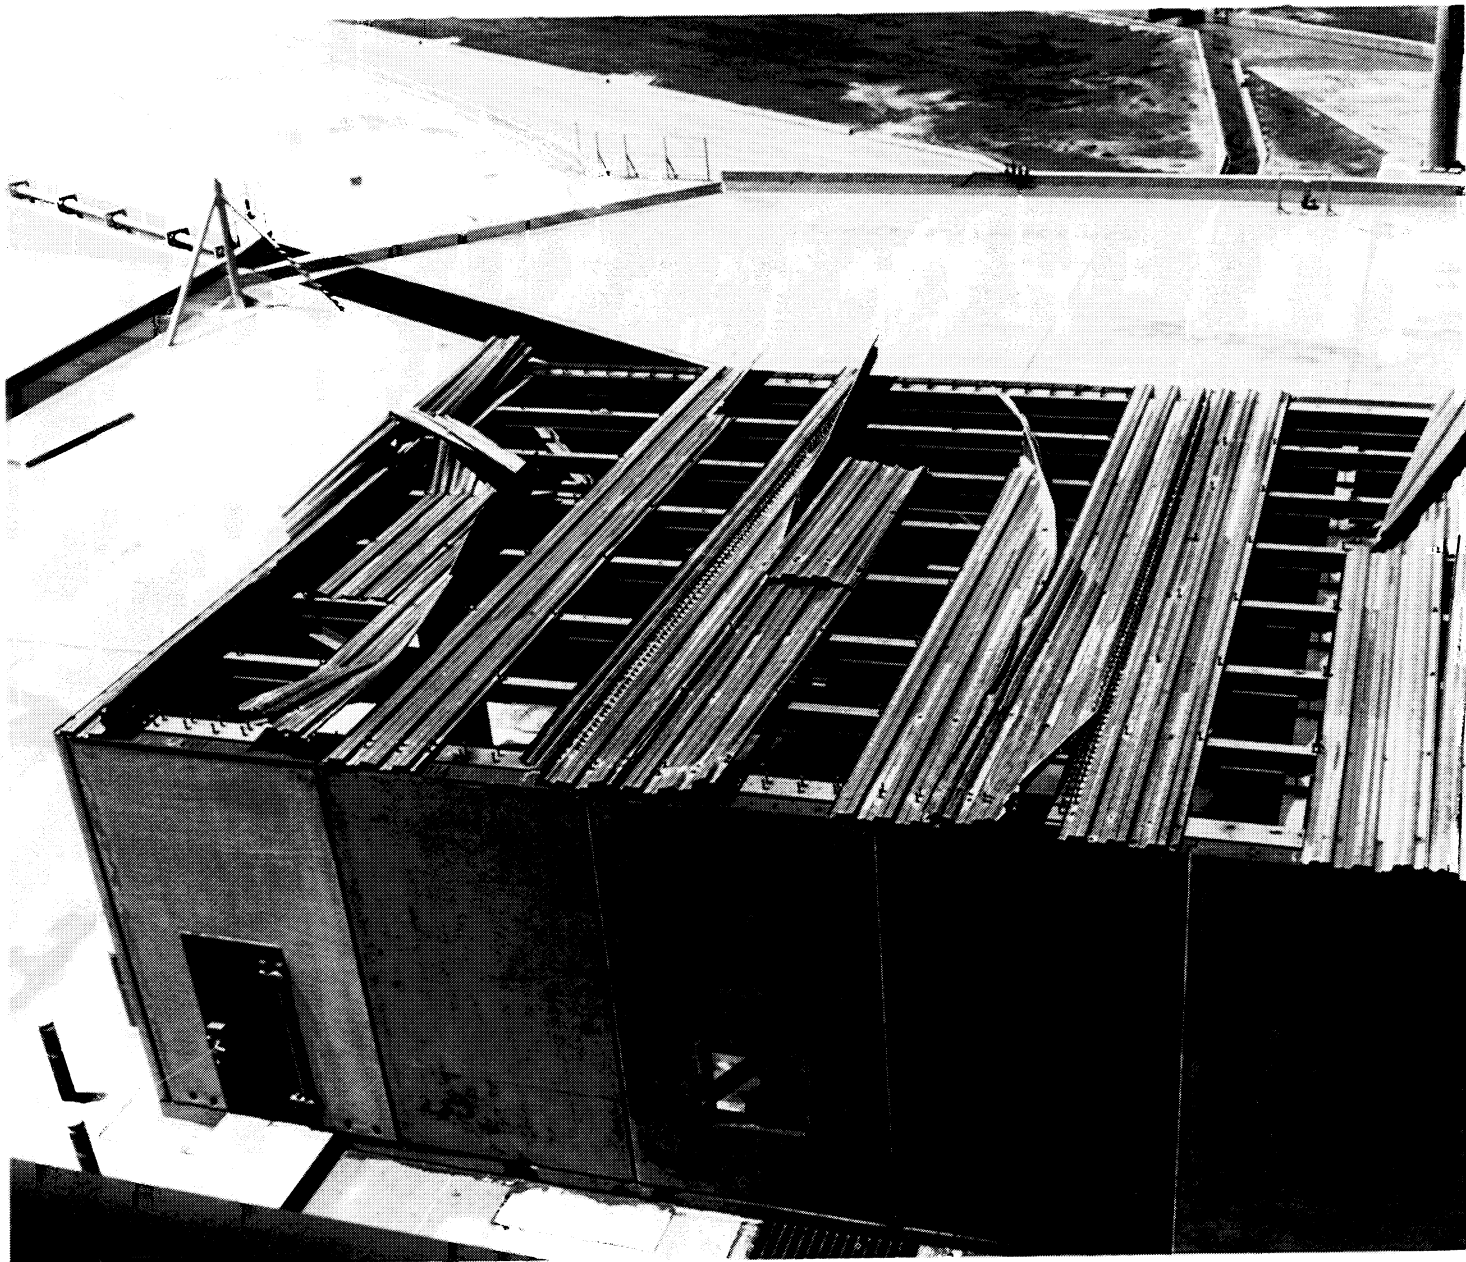
The new ECLSS building constructed adjacent to the FSS sustained severe roof damage from the launch. Pieces of sheet metal lay on the pad near the building, below the RSS, in the field west of the pad near the box cars and against the facility cooling tower.

Photo 9 : Post launch damage to new ECLSS building

Damage to the sheet metal roof was caused by a combination of SRB plume and wind out of the east as the vehicle cleared the tower. The sheet metal will be replaced with concrete prior to the next launch.

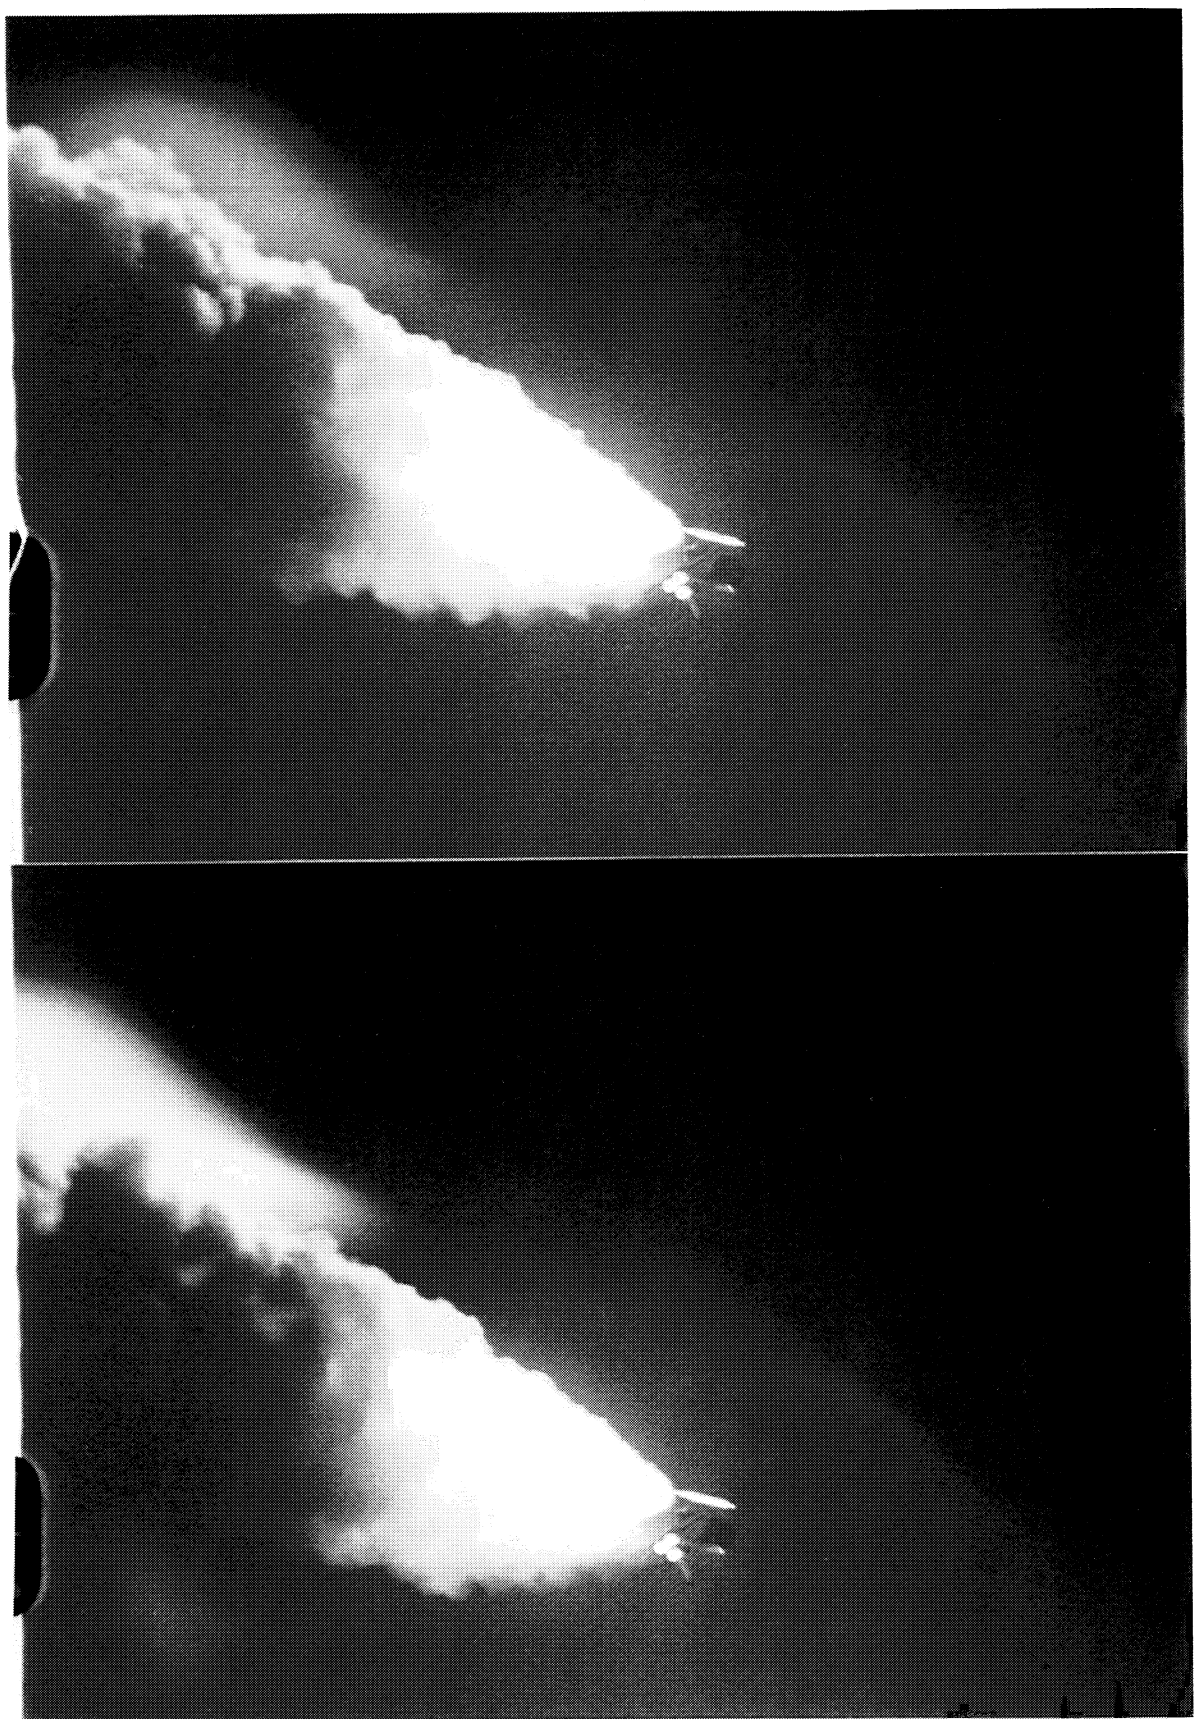
Photo 10 : Vapor cloud at T+58 sec. MET

A white vapor cloud formed aft of the vehicle along the flight path and was an aerodynamic induced phenomenon associated with atmospheric conditions at that time

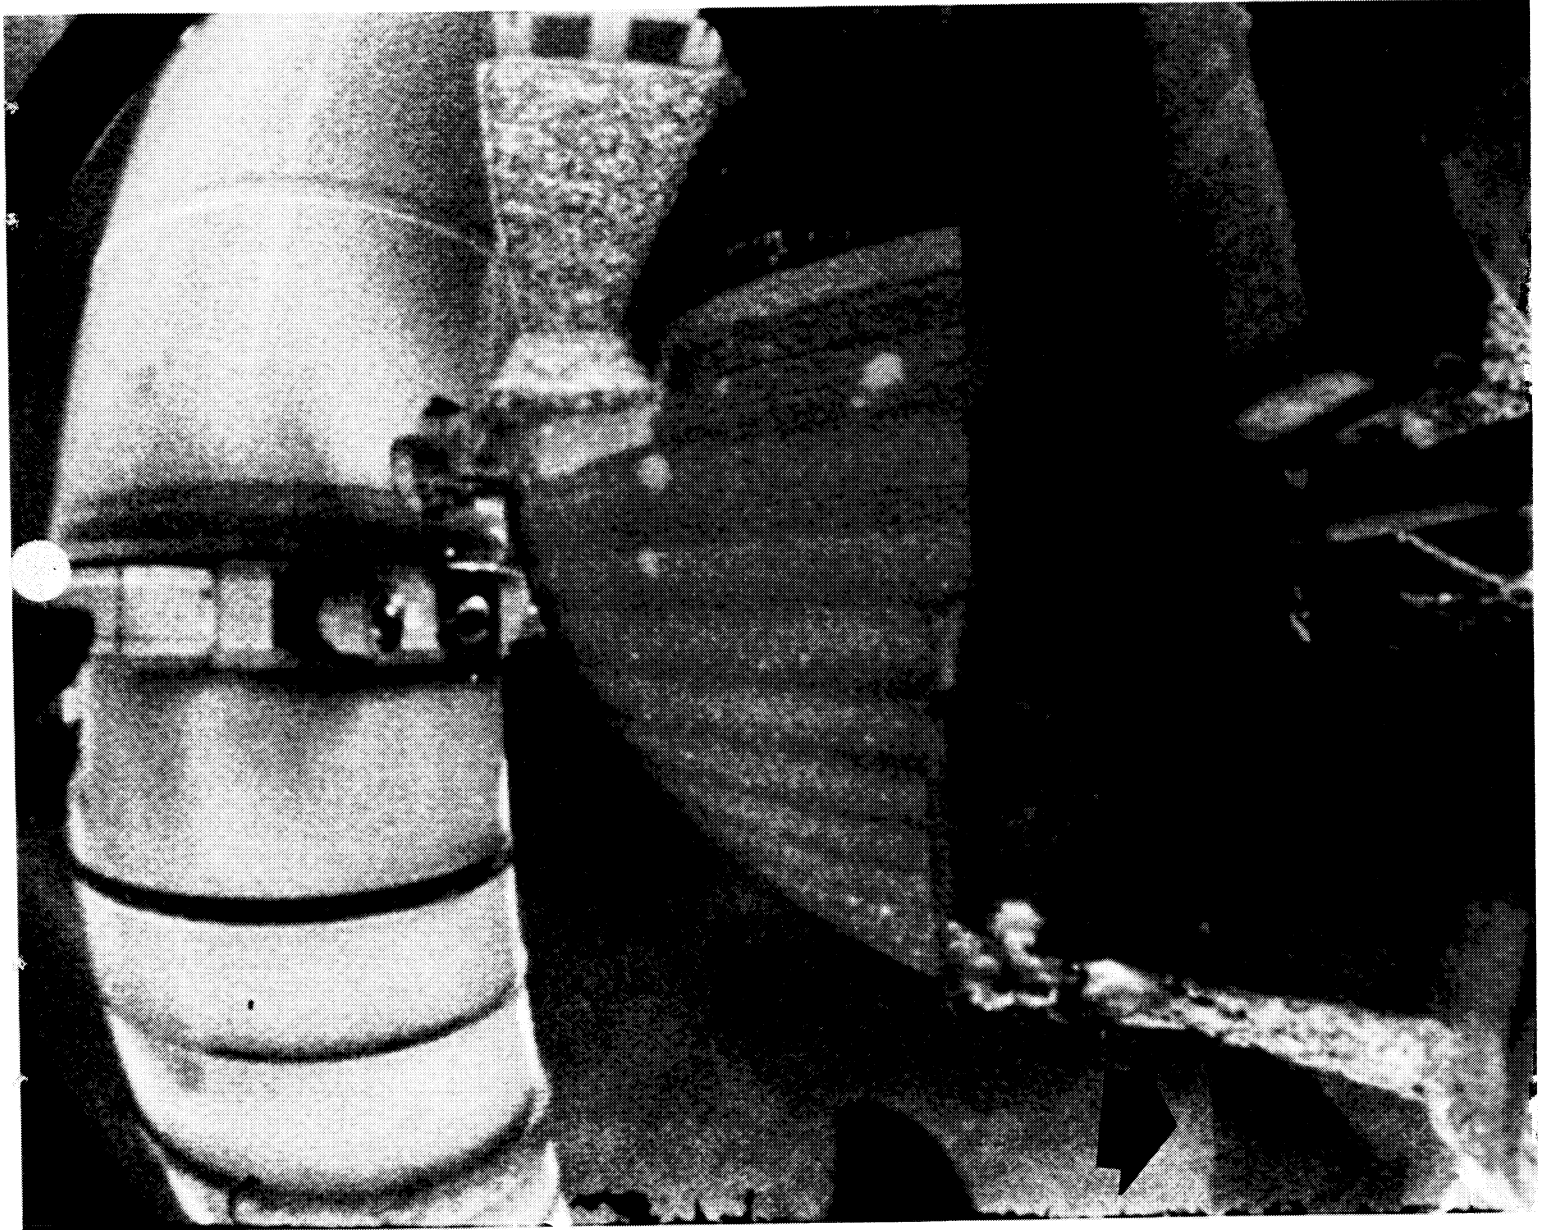
Photo 11 : SRB separation from External Tank

Structural separation of the SRB's from the External Tank appeared nominal. A piece of foam, approximately 12 inches by 8 inches by 1 inch, appeared to originate from the aft surface of the LH2 umbilical cable tray (arrow). Loss of TPS this thick may have exposed the substrate.

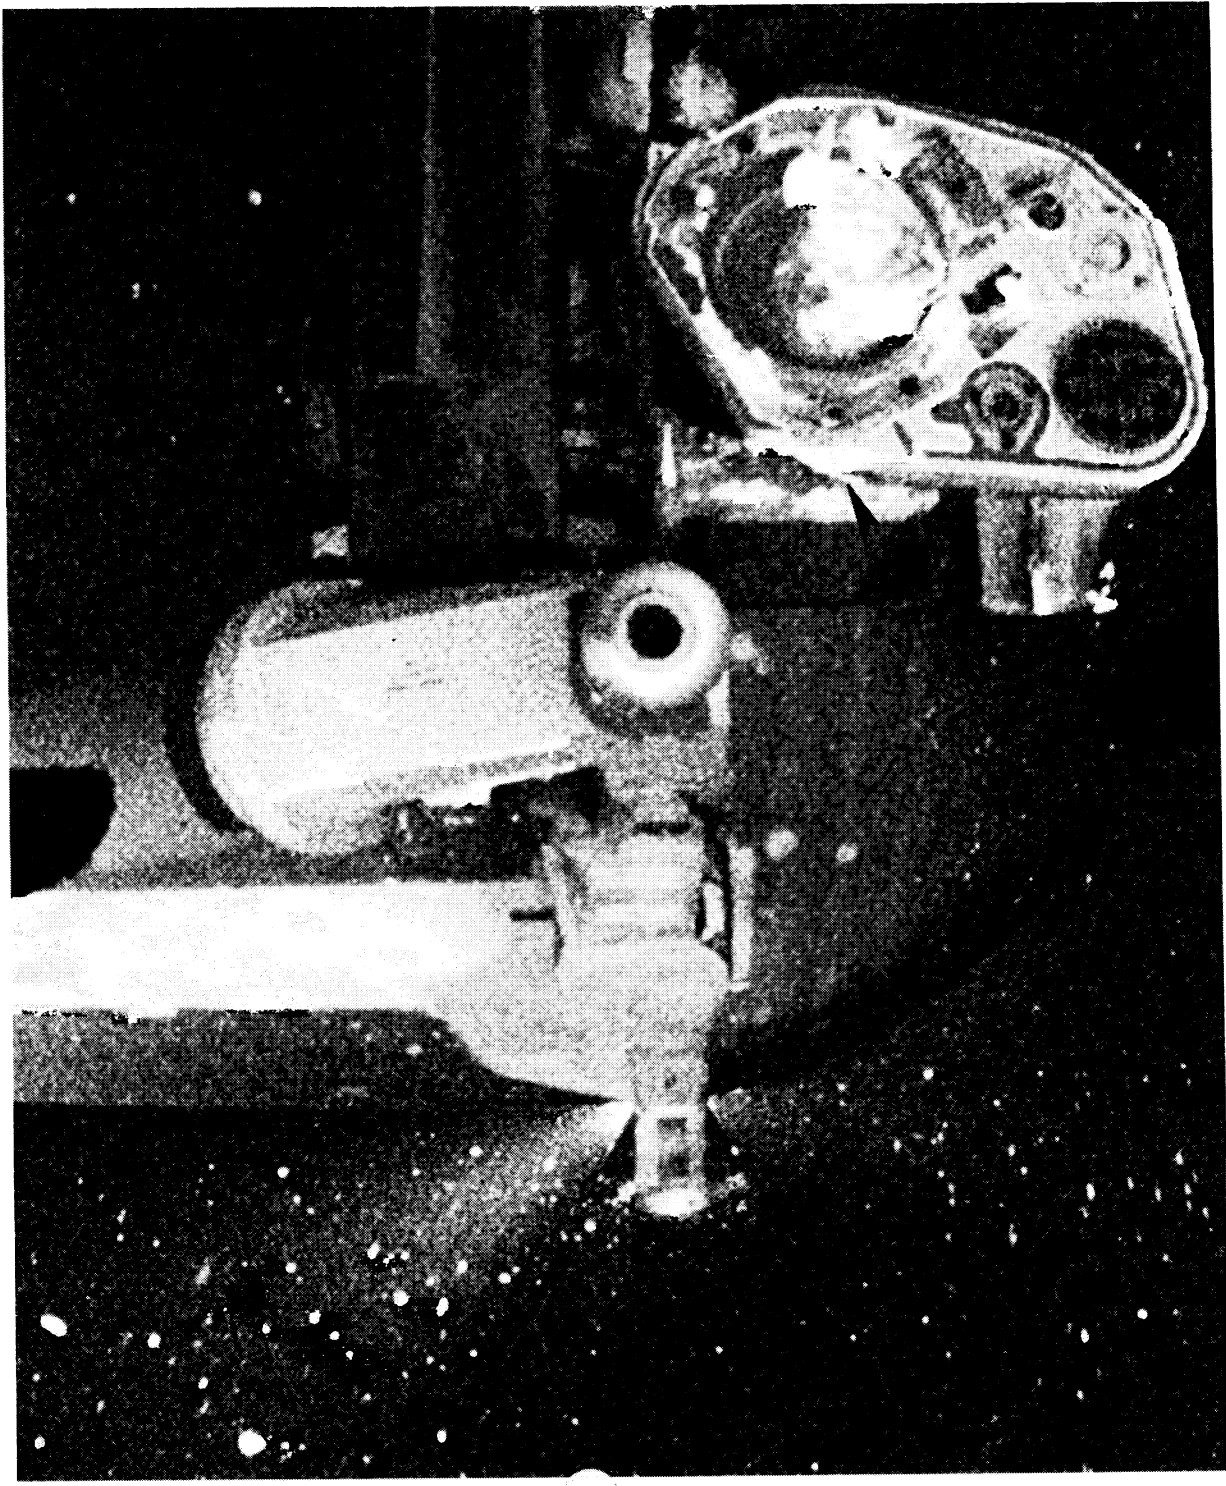
Photo 12 : LH2 ET/Orbiter umbilical after separation.

Structural separation of the ET from the Orbiter appeared nominal. Foam was peeling back on the side of the umbilical near the forward inboard and outboard pyro canister closouts. The white spot on the ET near the XT-2058 ring frame is ice/frost that formed near the TSE fitting.

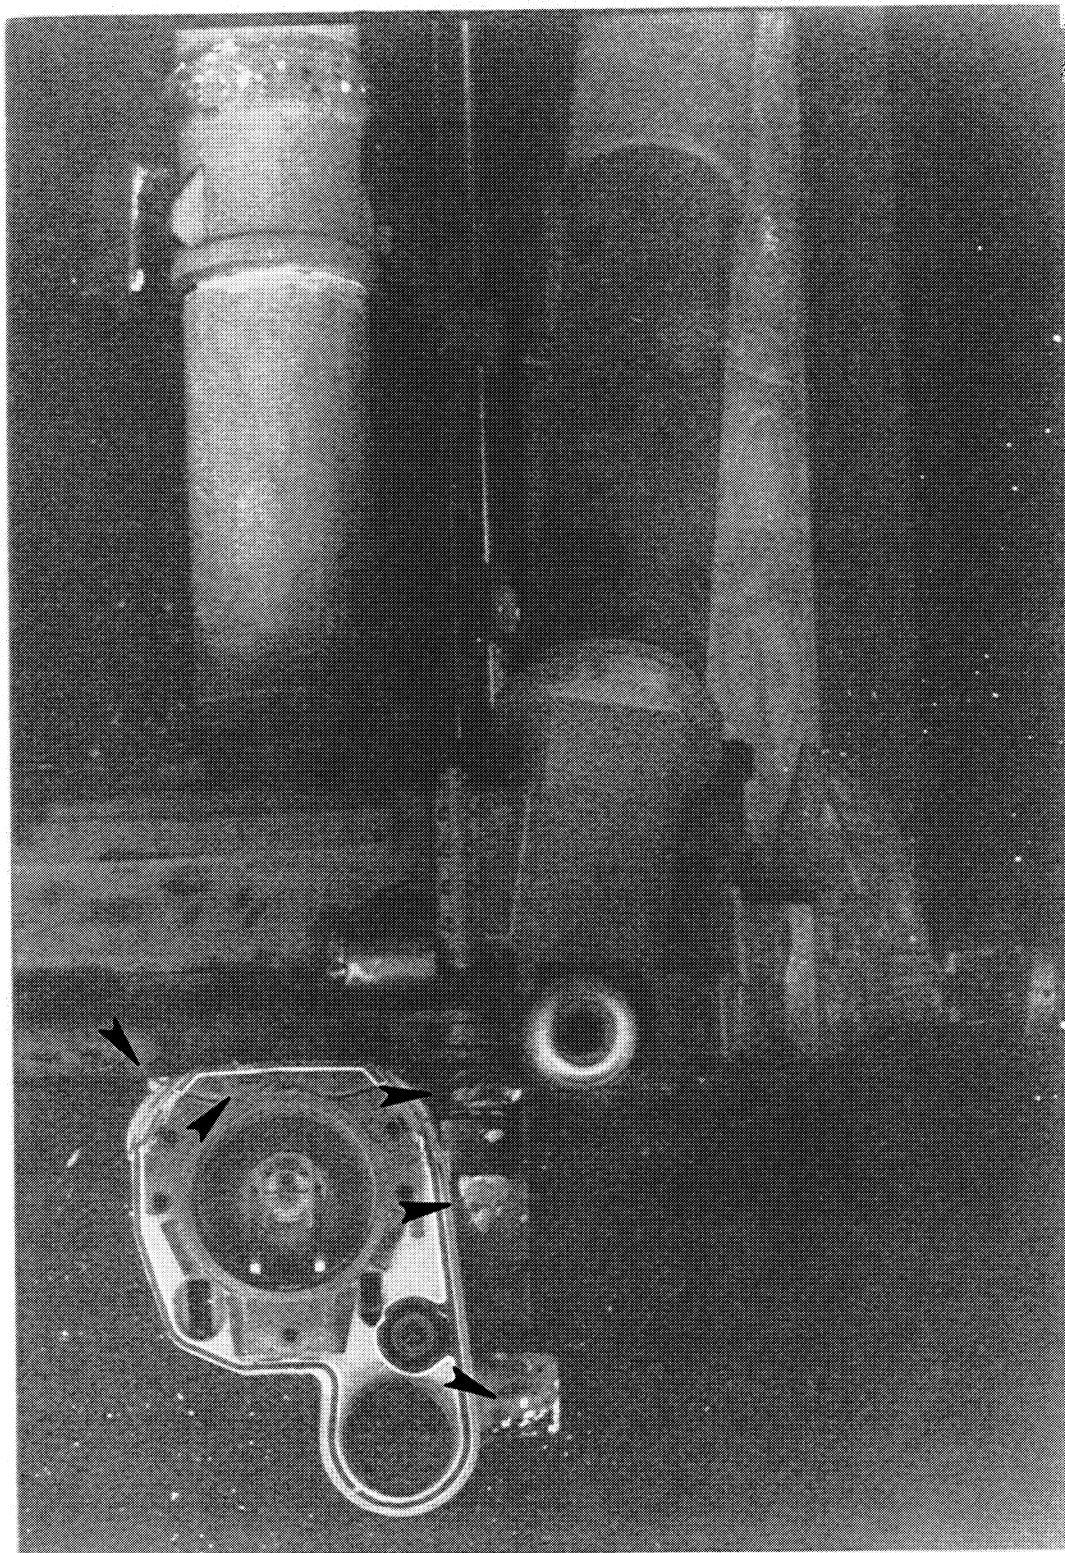
Photo 14 : LO2 ET/Orbiter umbilical after separation.

Foam on the forward inboard corner of the umbilical appeared slightly damaged. Numerous divots and eroded areas were visible on the horizontal and vertical sections of the cable tray. Although not definitive in the photographs, as many as four of the five lightning contact strips appeared to be missing from the interface plate.

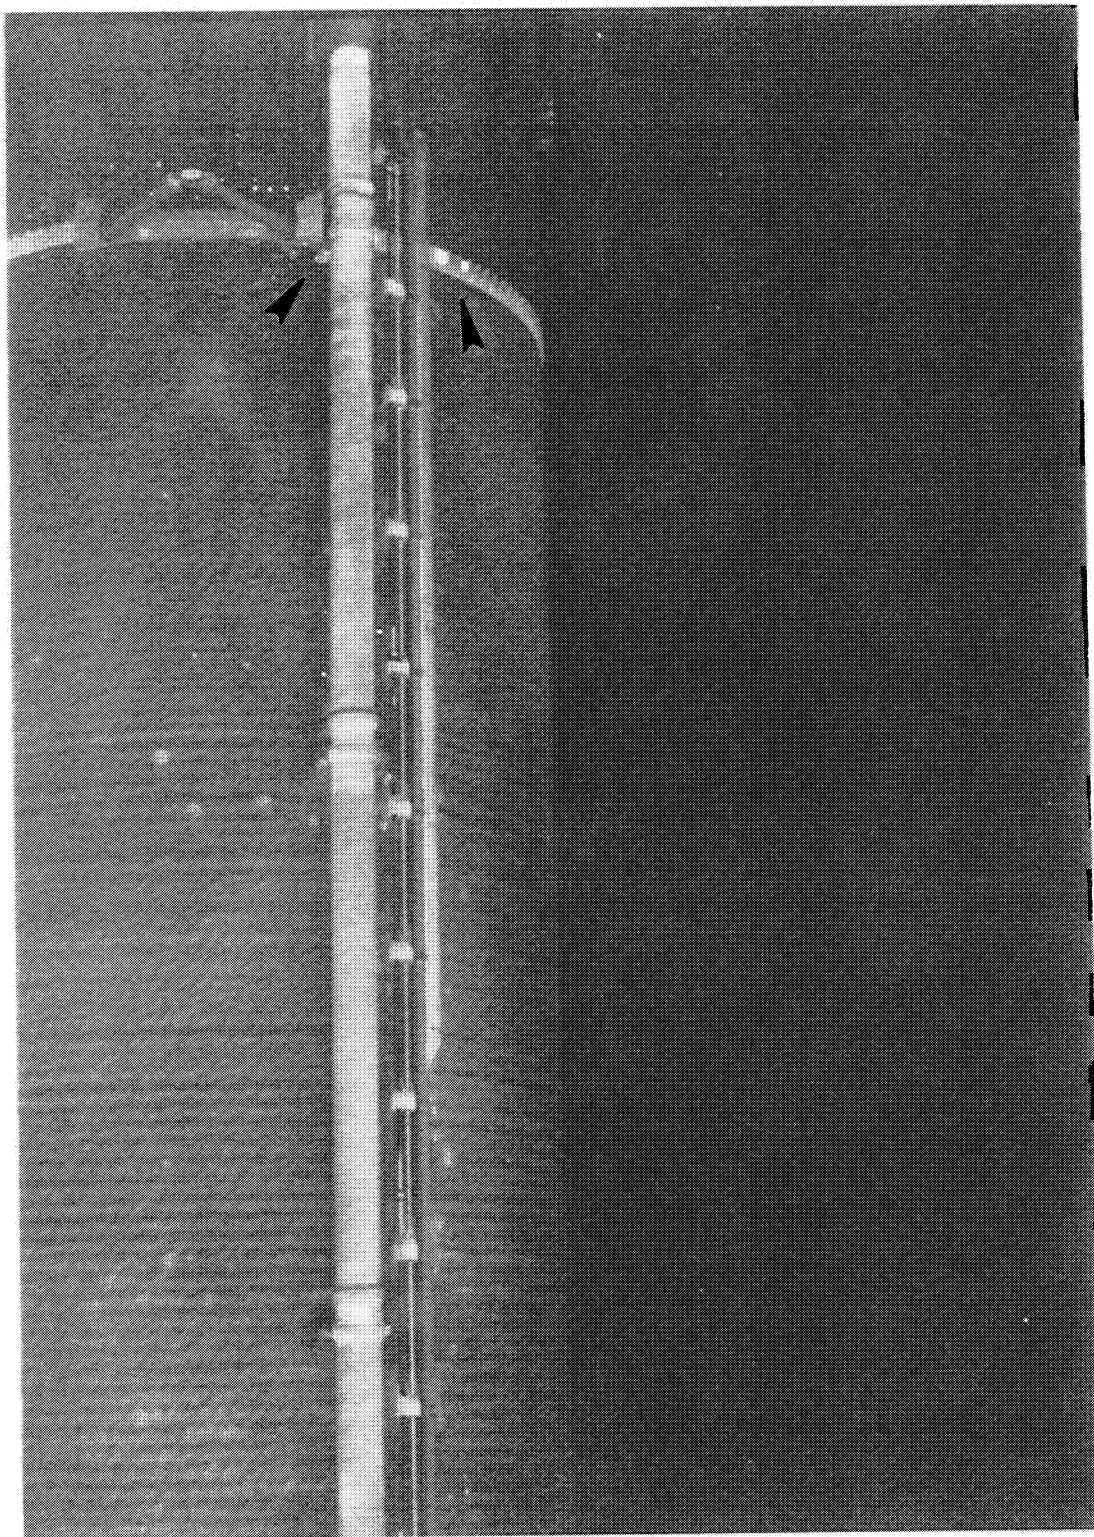
Photo 15 : On-orbit view of ET Intertank and Bipods

Two divots, 6 to 8 inches in diameter, were present in the LH2 tank-to-intertank flange closeout immediately to the +Y side of the PAL ramp. Both divots went to substrate and exposed the primer. A divot, 6 inches in diameter but shallow in depth, occurred in the LH2 tank acreage just aft of the LH2 tank-to-intertank flange closeout between the right (+Y) bipod spindle housing closeout and the LO2 feedline support bracket. Both bipod jack pad closeouts were intact and appeared to be in excellent condition.
